**REPORT NUMBER: NCAP-CAL-13-017**

**NEW CAR ASSESSMENT PROGRAM (NCAP)  
FRONTAL BARRIER IMPACT TEST**

**General Motors LLC  
2013 Chevrolet Traverse  
Four Door SUV**

**NHTSA No: MD0117**

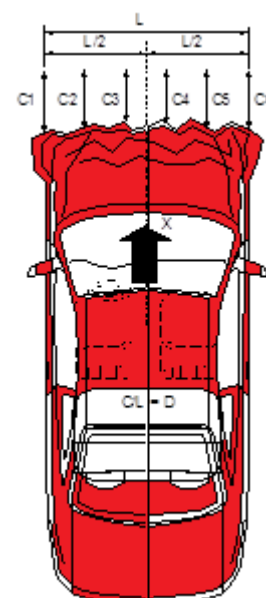
**CRUSH PROFILE**

Collision Deformation Classification: 12FDEW2  
 Midpoint of Damage: Vehicle Centerline  
 Damage Region Length (mm): 1,152  
 Impact Mode: Frontal

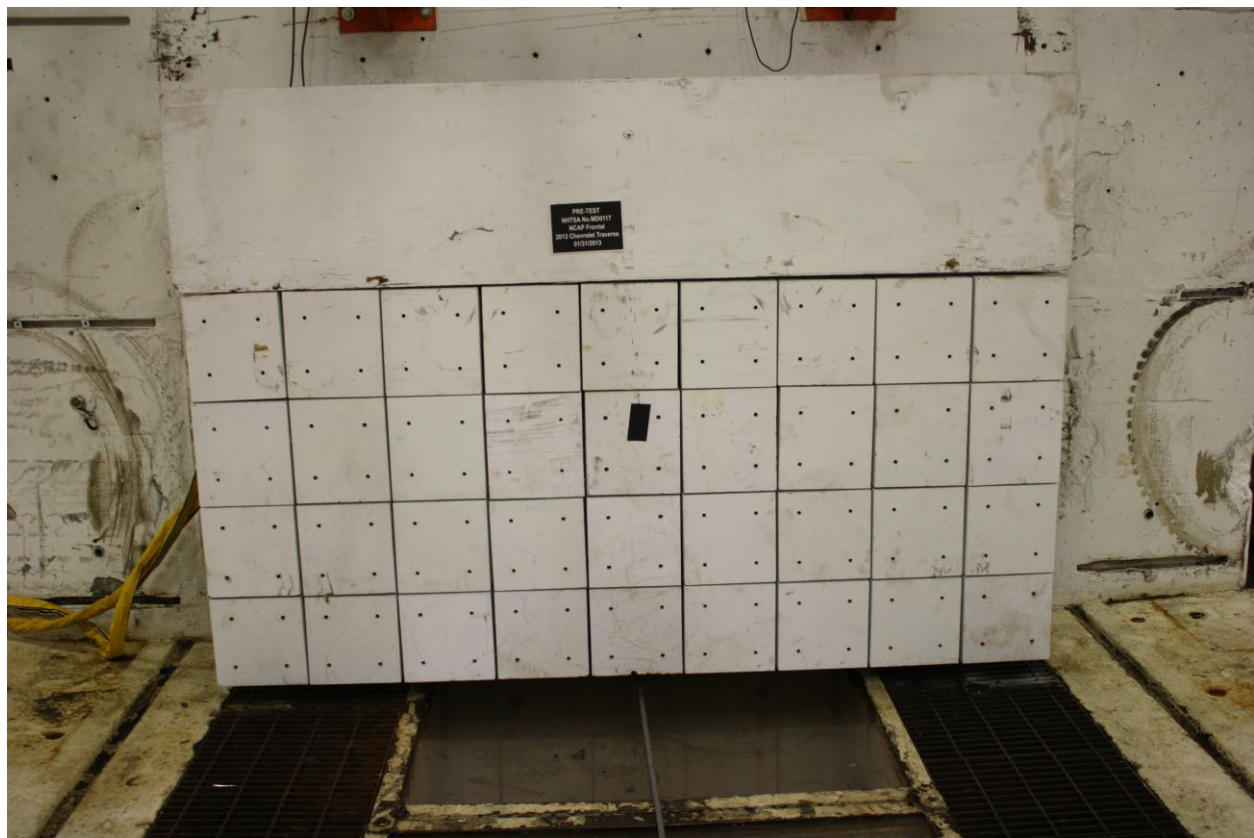
**Figure A-2: Load Cell Wall**

A load cell barrier consisting of 36 load cells was impacted by a 2013 Chevrolet Traverse four door SUV at a velocity of 56.36 km/h. The test was performed at Calspan Corporation's Transportation Test Operations facility in Buffalo, New York on January 31, 2013. Pre- and post-test photographs of the vehicle and dummies to document the test can be found in Appendix A. One real-time camera and 16 high-speed cameras were used to document the frontal barrier impact event. Camera locations and other pertinent camera information can be found in Data Sheet 6 of this report.

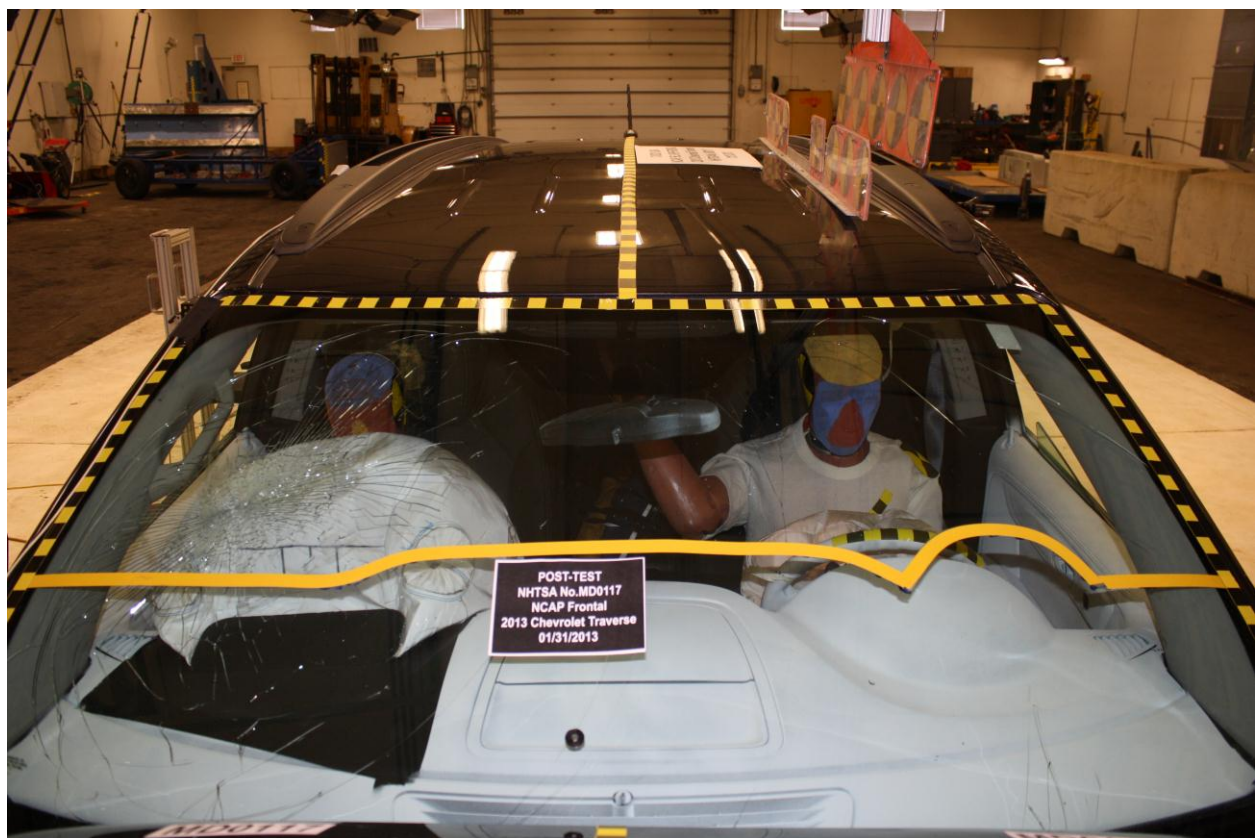
**Figure A-18: Post-Test Windshield View**

Critical Areas of Performance	Observations and Conclusions
Windshield Damage	Cracks prominent on Passenger side, caused by airbag deployment
Window Damage	None
Other Notable Effects	None

There was 100% percent windshield retention and no intrusion into the protected zone of the windshield during the event. There was a total of 0.0 grams of stoddard solvent leakage after the event and including all phases of the static rollover. The maximum static crush of the test vehicle was 538 mm at the vehicle's centerline. During and after the impact event, the driver's side door remained closed and operational and the passenger's side door remained closed and operational.

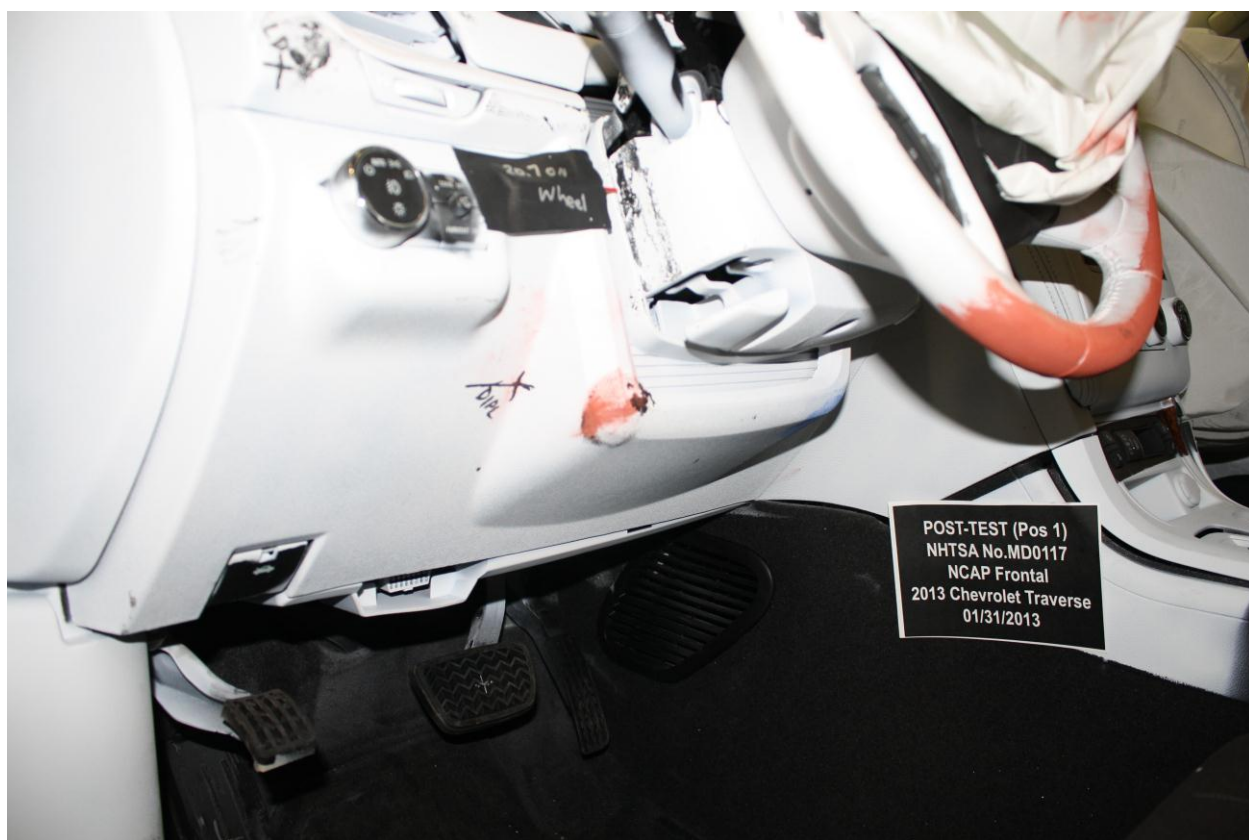
**Figure A-42: Post-Test Driver's Side Knee Bolster**

The driver's visible contact points were as follows: The driver's head contacted the frontal airbag and then the head restraint. The upper torso contacted the frontal airbag. Both knees contacted the knee bolster.

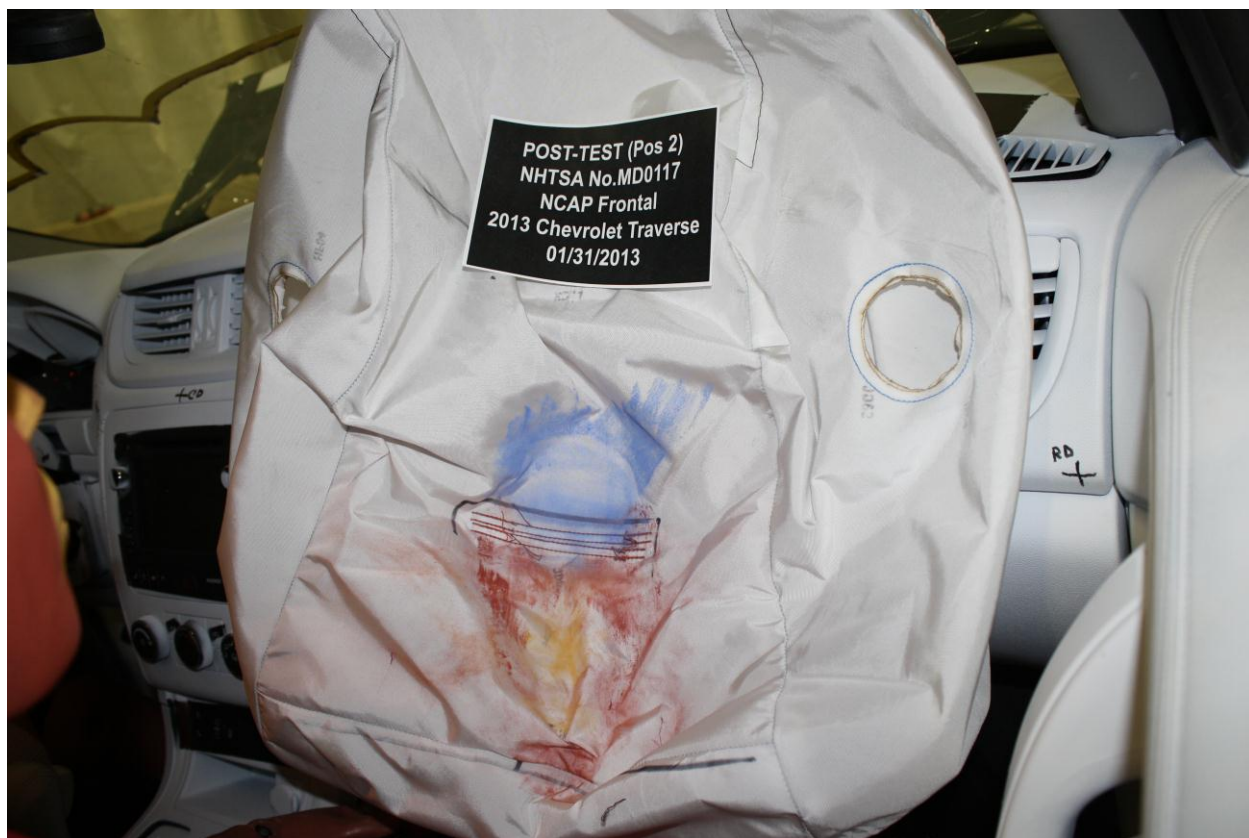
**Figure A-66: Post-Test Passenger Dummy Contact With Airbag**

The passenger's visible contact points were as follows: The passenger's head contacted the frontal airbag and then the head restraint. The upper torso contacted the frontal airbag. Both knees contacted the glovebox.
